MOHAWK RIVER WATERSHED  
PECK CREEK BASIN

**PECK LAKE DAM**  
FULTON COUNTY, NEW YORK

**PHASE I INSPECTION REPORT**  
**NATIONAL DAM SAFETY PROGRAM**

Prepared by  
CONVERSE WARD DAVIS DIXON  
CONSULTING ENGINEERS  
91 ROSELAND AVENUE, P.O. BOX 91  
CALDWELL, NEW JERSEY 07006

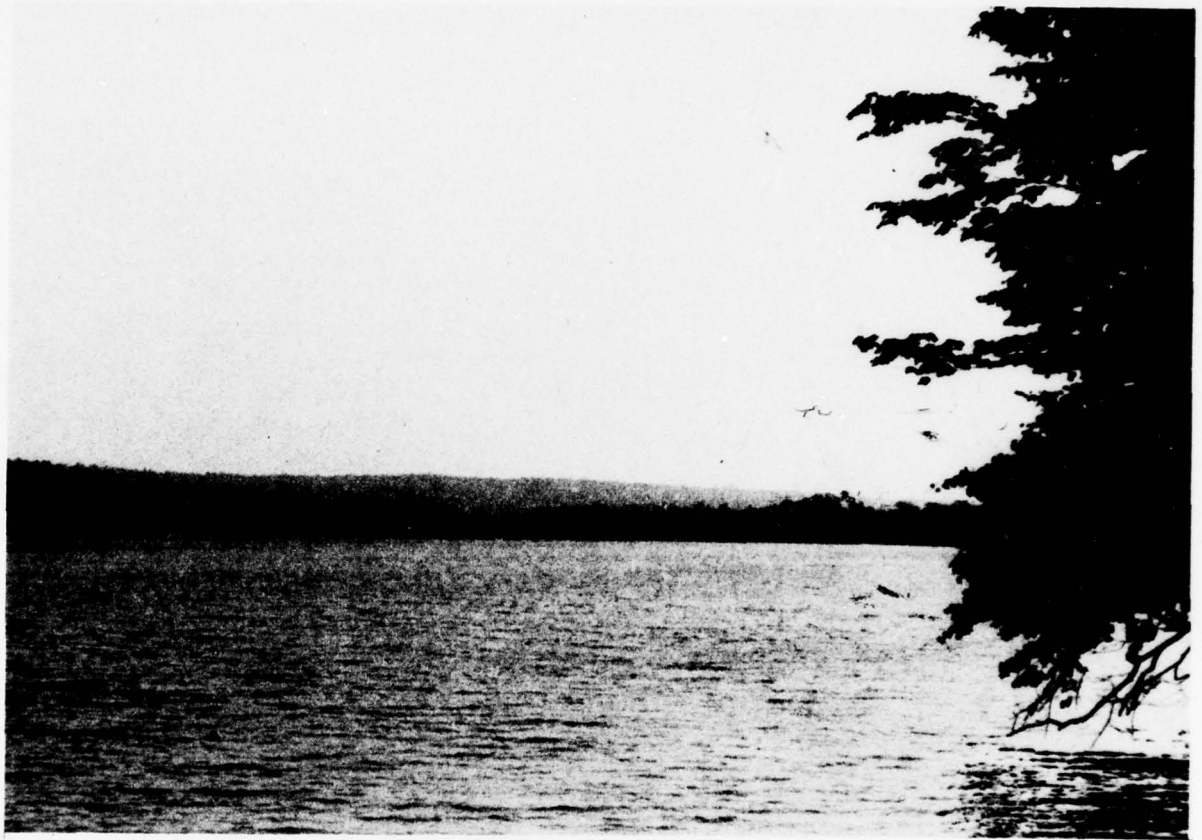
OVERVIEW - ACROSS LAKE, PECK LAKE DAM

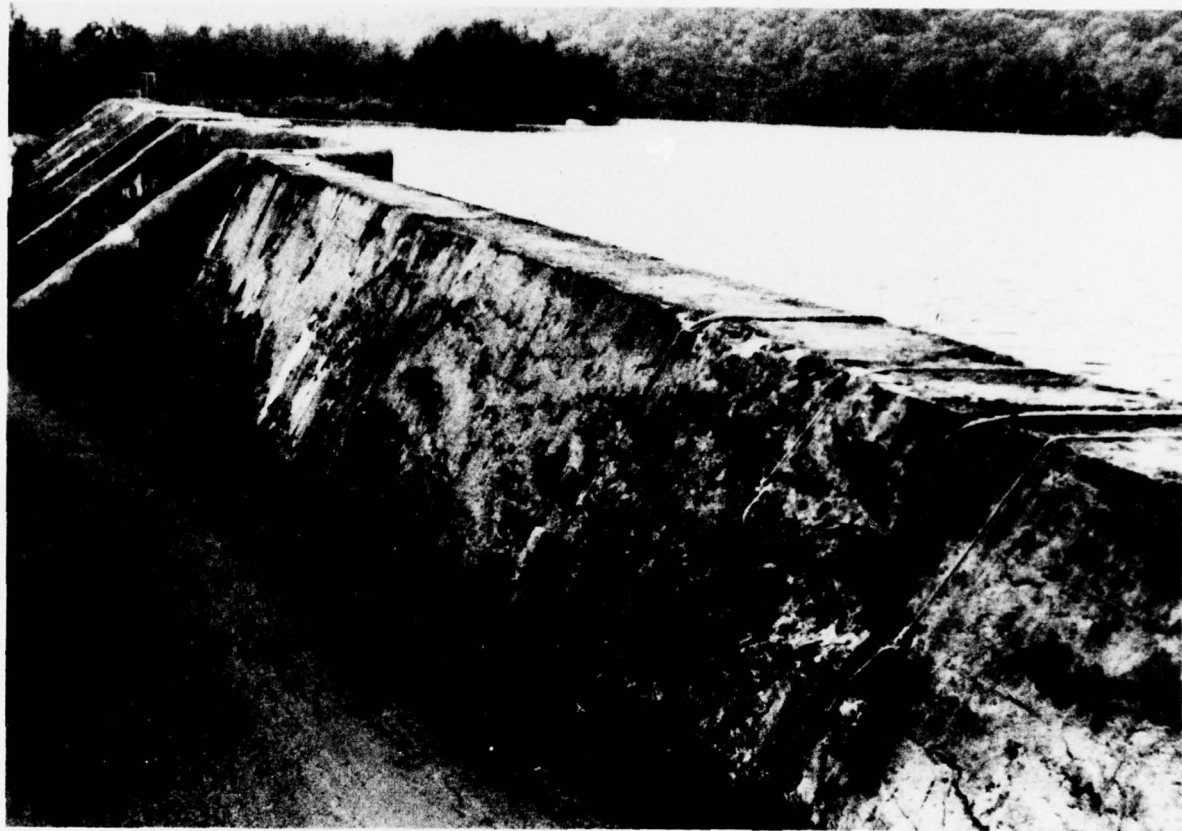
OVERVIEW - FROM DOWNSTREAM FACE, PECK LAKE DAM
